DYNAMIC SCIENCE, INC.
In-Depth Accident Investigation

Contract Number DTNH22-94-D-27058
Case Number DSI-94-AB-020

TECHNICAL SUMMARY

CONTRACTOR: Dynamic Science, Inc.
CONTRACT NUMBER: DTNH22-94-D-27058
CASE NUMBER: Case DSI-94-AB-20

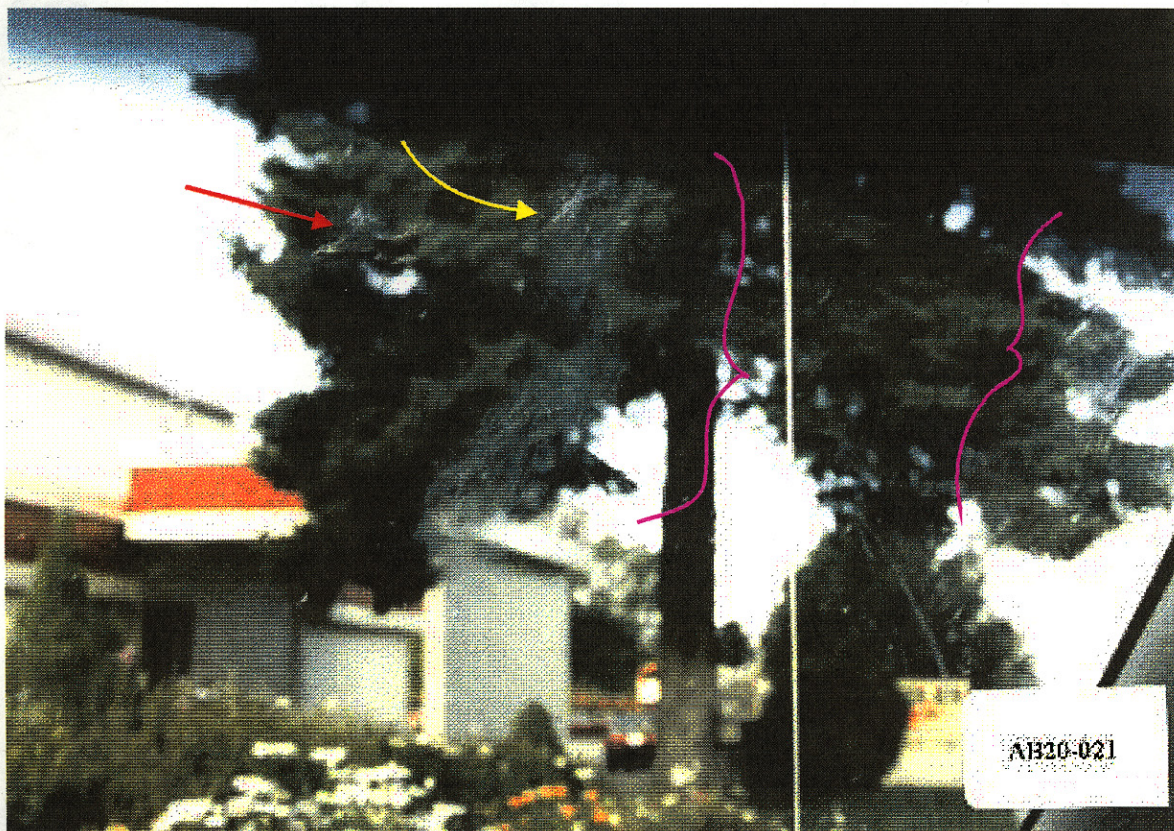
Photograph #21 (Police Photograph)

There are smudge marks on the windshield from the powder residue of the airbag.

The red arrow is pointing to an unknown object that is embedded on the windshield. It probably came from the "backing" paper that some air bags are "wrapped" in. An exemplar vehicle was inspected, and this "backing" paper was present. It was torn and present behind the air bag module.

Neither the smudge marks or the object were visible when Vehicle 1 was inspected.

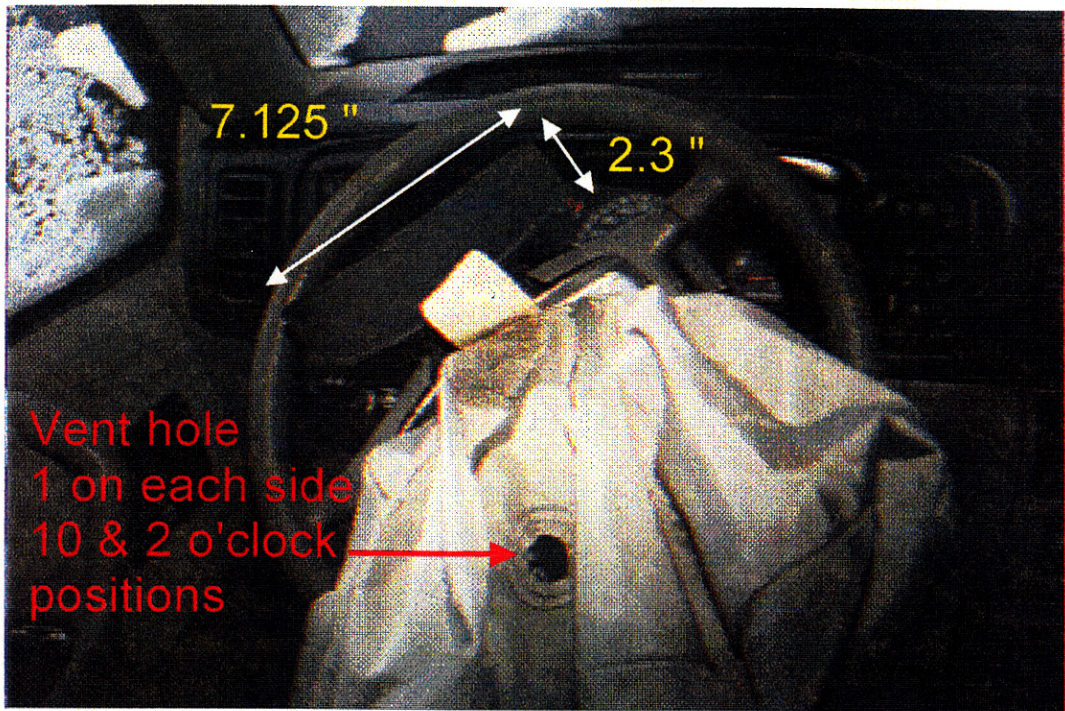
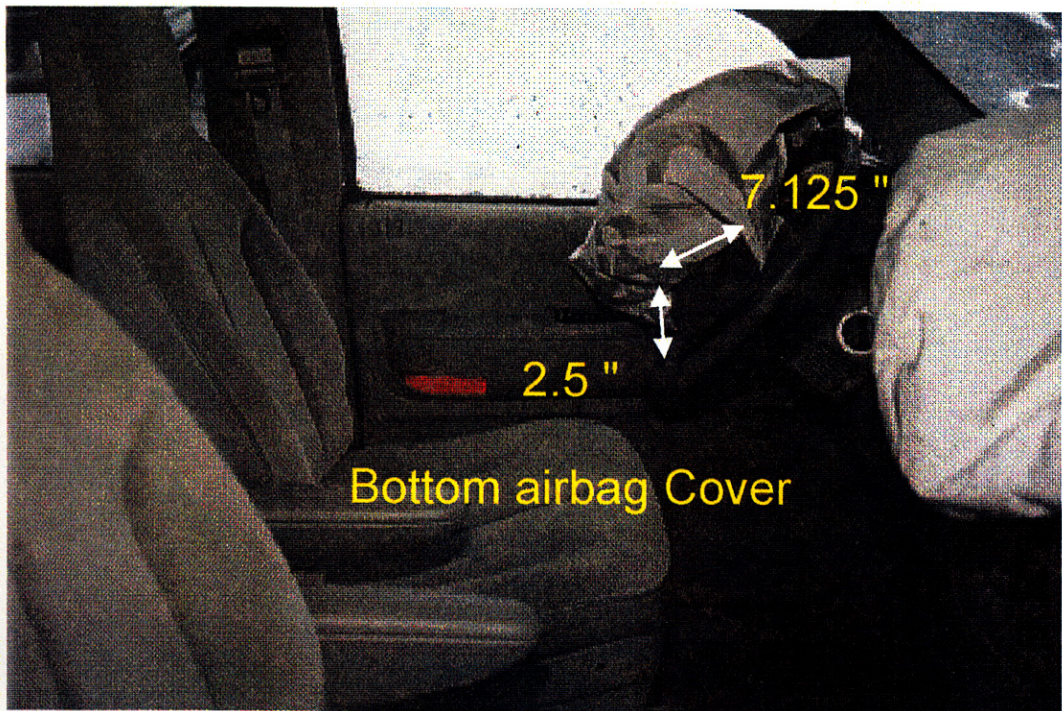
Upper and Lower airbag covers

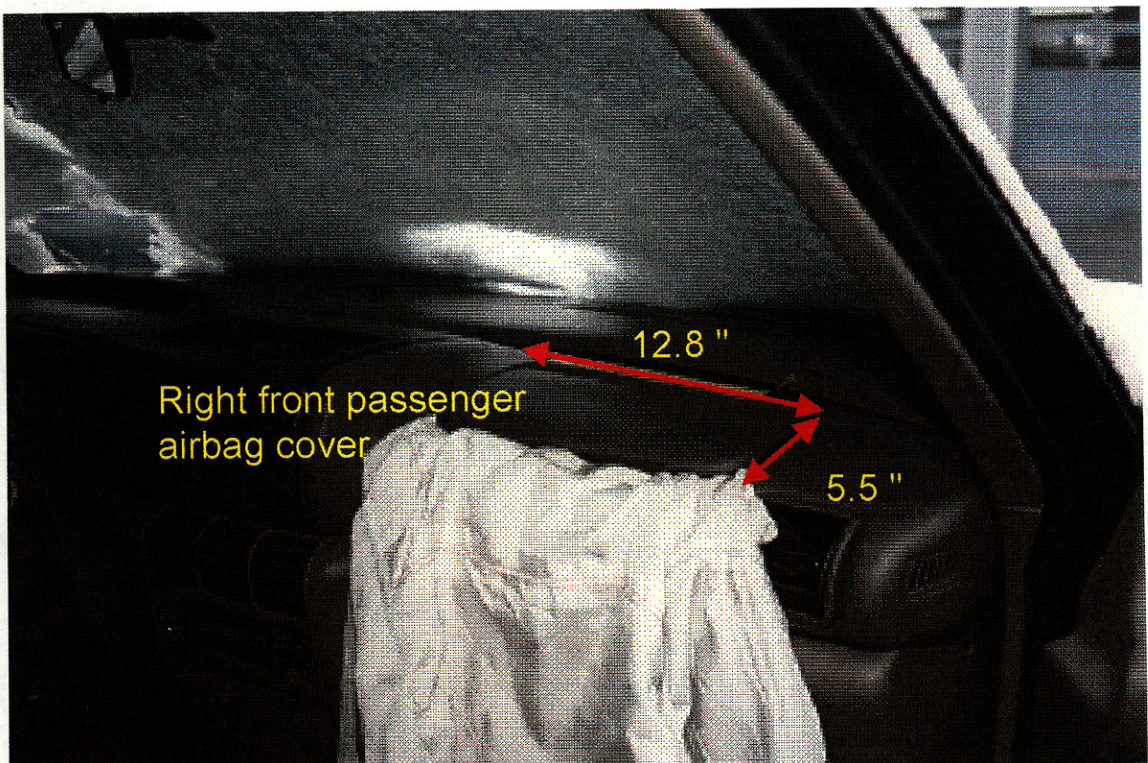
located on the left half of the air bag, whose source could not be identified. There were also blood stains on both of the air bags in the lower left corners that were most likely the result of post-crash bleeding by occupant 2, the right front occupant. This probably occurred when the driver of Vehicle 1 pulled the R/F occupant out the left front door and laid her on the ground.

The right front occupant was the source of the bleeding

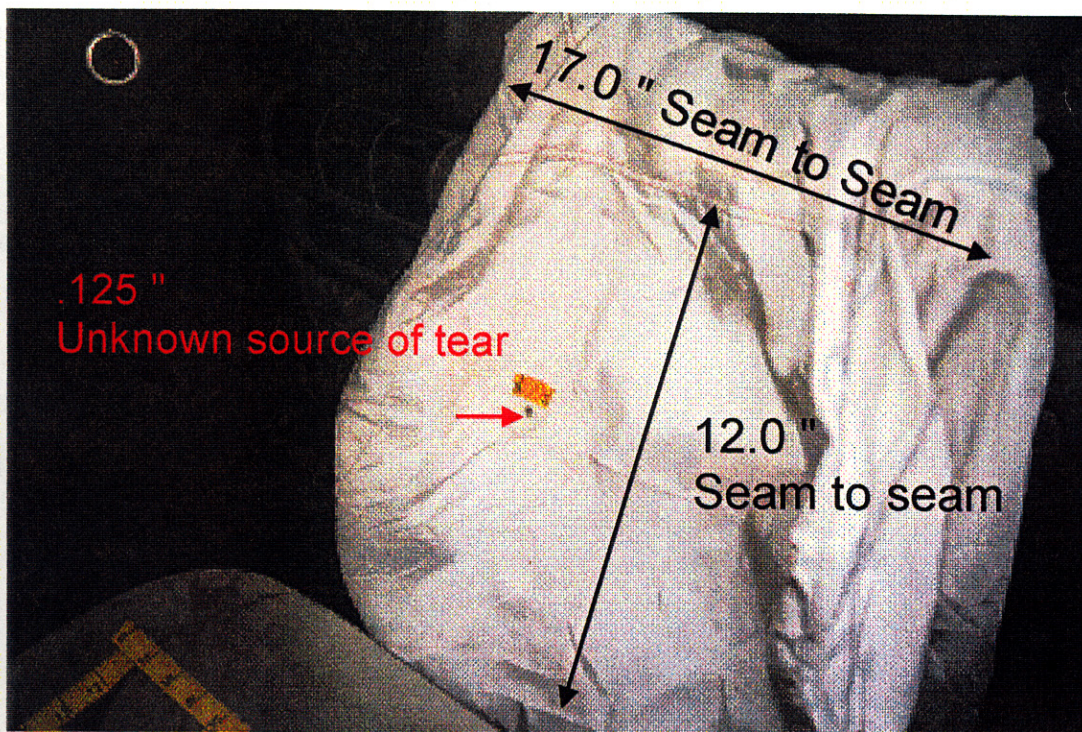
Driver and right front occupant airbags

The driver's air bag was not damaged during the collision sequence and did not yield evidence of occupant contact. However, the right side occupant's air bag had a 0.3 cm (0.12 in) tear,

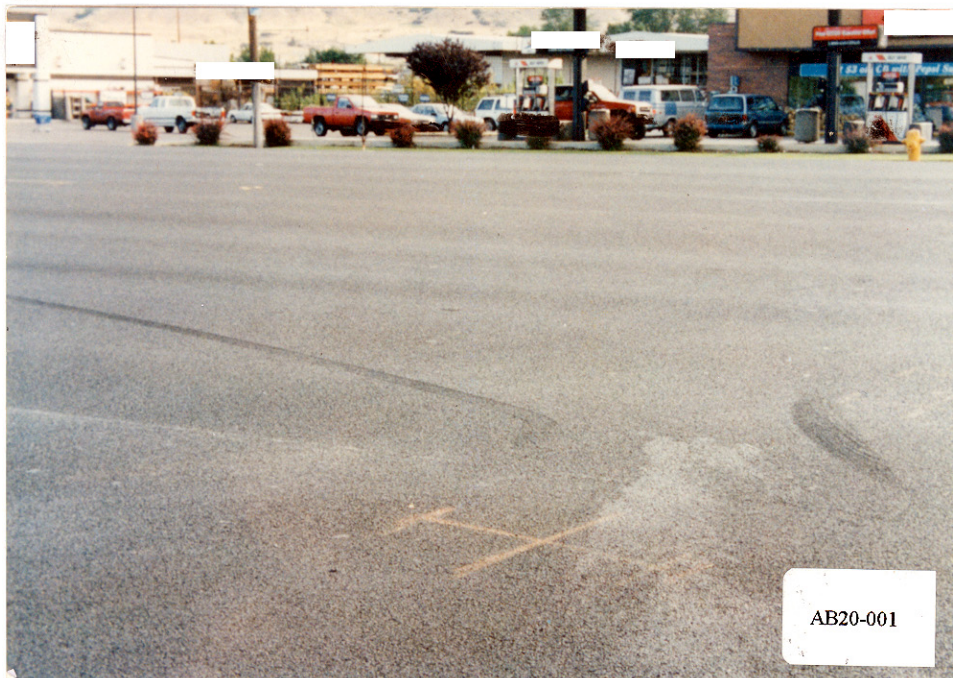
AB20-001

PHOTO NO.	VEHICLE NO.	ORIENTATION	SUBJECT MATTER
			***The following photographs were taken by police at the scene of the collision.
01-04	01 & 02	North-East	LF-skidmark of V1 braking post impact an at impact. RF-skidmark of V2 at impact.
05	01 & 02	North-East	Debris and fluid spill of both vehicles leading away from impact area towards final rest area.
06-07	01	East	Final rest.
08-13	01		Exterior damage to Vehicle 1.
14-19	01		Interior of Vehicle 1.
20-21	01		Right side of windshield, smudge marks made by air bag powder residue. There is also something on windshield, it is not known if this was something placed to highlight smudge marks, origin is unknown.
22-23	01		Right front occupant seat.
24	01		Area in between both front seats, and area where right front occupant came to rest after impact.
25-26	01		Area behind front seats.
27	01		Rear seat.
28-34	02		Exterior damage to vehicle.

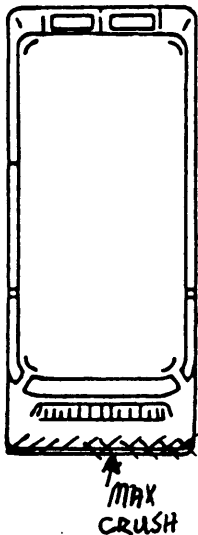
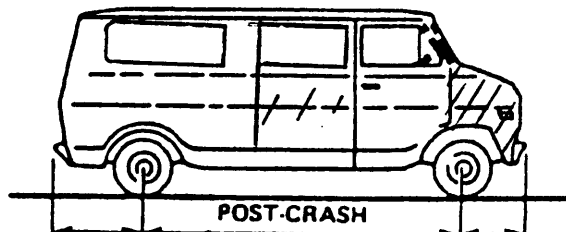
VEHICLE DAMAGE SKETCH

Bumper corner 29.3" (74.4 cm) 119.9" (304.5 cm) 90.8" (231.1 cm) Bumper corner
 Stringline 34.0" (86.3 cm) 304.5" (773.1 cm) 99.4" (252.5 cm) Stringline

Bumper corner 36.75" (93.3 cm) 119.8" (304.2 cm) 68.5" (174.1 cm) Bumper corner
 Stringline 40.5" (102.8 cm) 304.2" (772.8 cm) 82.8" (210.4 cm) Stringline

DIRECT DAMAGE
 BUMPER 38.0" (96.5 cm)
 HOOD 35.5" (90.1 cm)

The front bumper of Vehicle 1 struck the right front quarter panel of Vehicle 2. The Delta V for Vehicle 1 was computed, using EDCRASH, as 13 KPH (8 MPH) using a CDC of 12FYEW1 and a PDOF of 350 degrees. The combined direct and induced damage width was 151.3 cm (59.6 in), and the maximum crush depth was 18.7 cm (7.3 in). The Delta V forces in this impact exceeded the manufacturer's threshold in the Supplemental Restraint System (SRS), and the driver's and passenger's side air bags in Vehicle 1 deployed.

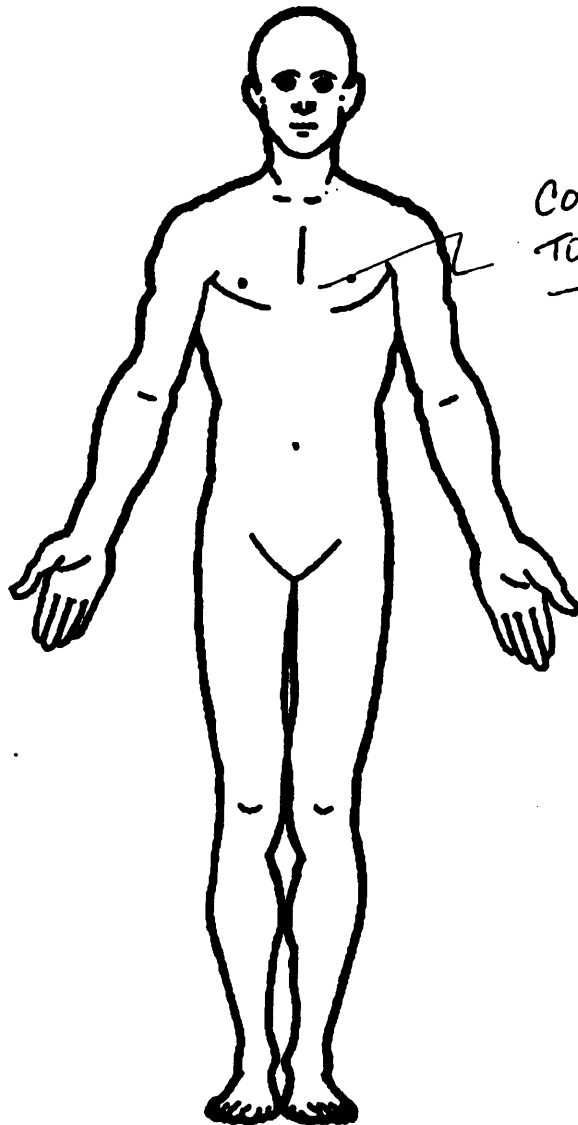
CONTUSION
TO CHEST
AIRBAG

The driver of Vehicle 1 was not wearing the available lap/shoulder restraint. She sustained a contusion to her chest from contact with the air bag and a burn to the chest area of her dress, that she claims occurred as a result of contact with gases from the air bag. She was transported to a local hospital via ambulance where she was treated and released.

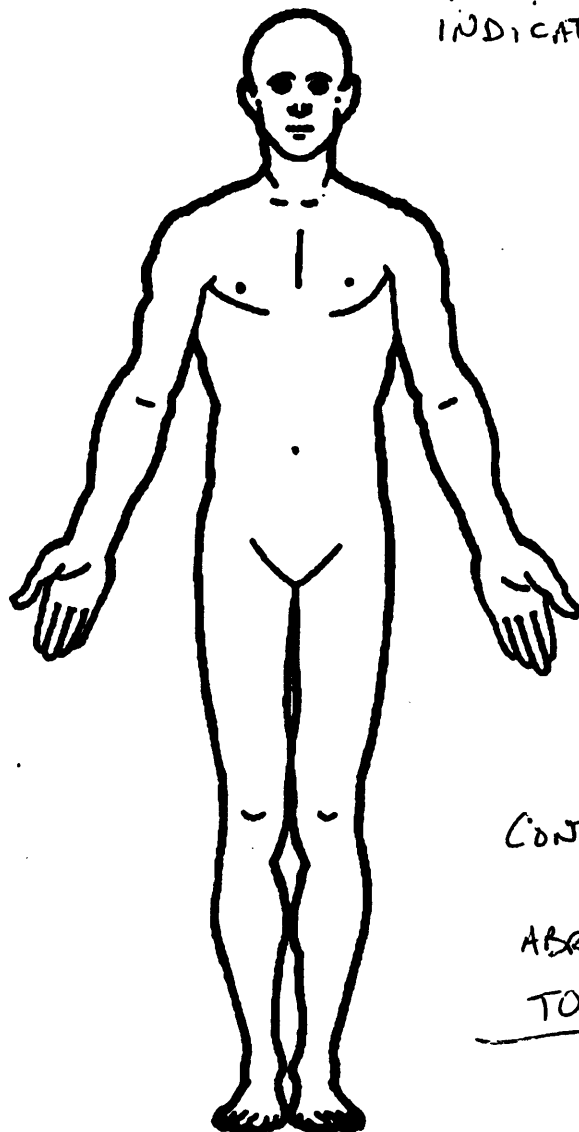
CODED PER PAR ONLY.
DRIVER & EMERGENCY RECORDS
INDICATED NO INJURIES

CONTUSIONS
&
ABRASIONS
TO LEG(S)

The rear seated ten year old female occupant of Vehicle 1 was not wearing the available lap/shoulder restraints. According to the PAR, she sustained bruises and abrasions to her leg(s). The driver and the Emergency Room Medical Report indicated she was not injured.

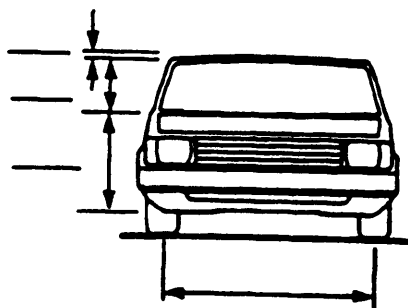
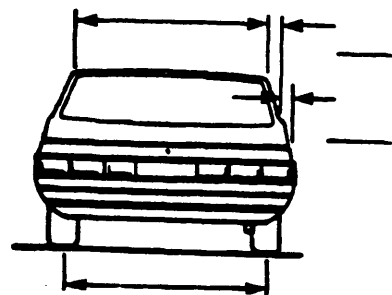
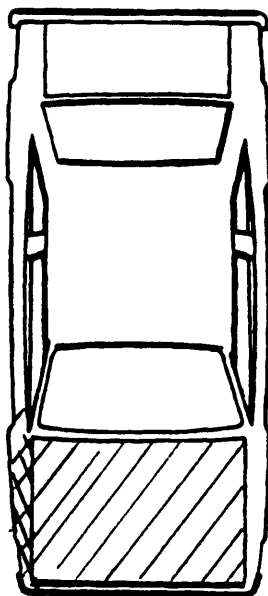
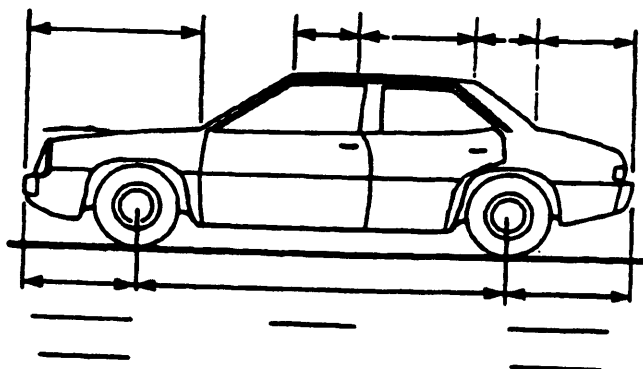
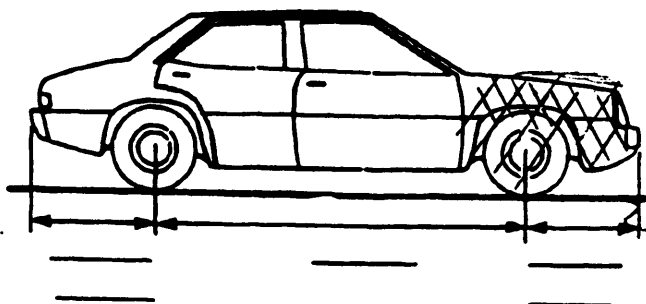
DAMAGED
FRONT
STEERING
SUSPENSION

Vehicle 2 sustained moderate damage, and its right front suspension was damaged. The driver of the vehicle fled the scene but was apprehended at a later time. The vehicle was towed from the place where the police found it.

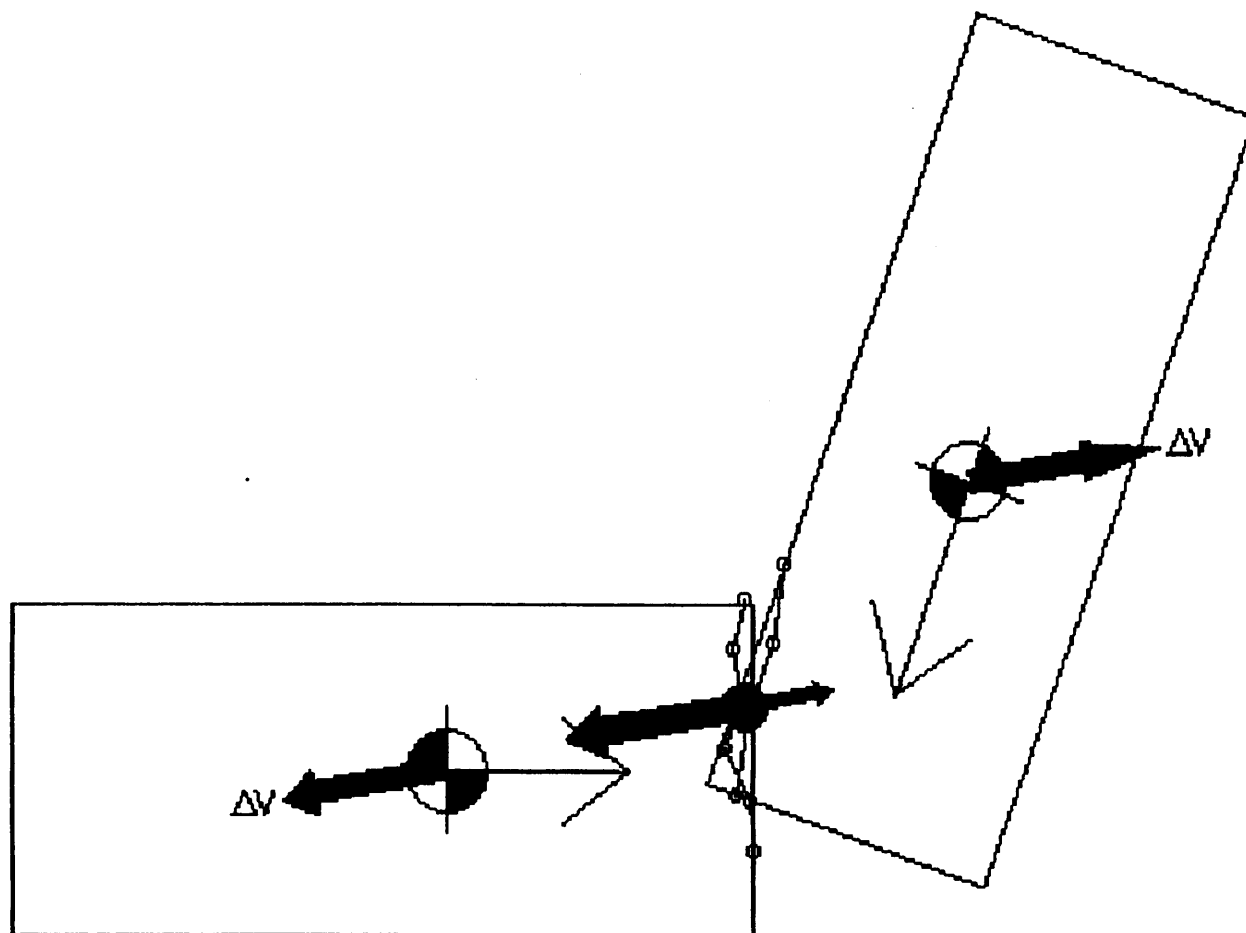
EDCRASH
At Impact

Veh #1	Veh #2
Delta-U (mph):		
X	-8.1	-4.8
Y	1.4	-8.4
Tot	8.3	9.7

Crush Data (in):		
W	60.0	56.6
D	-11.0	62.0
C1	2.6	0.0
C2	4.9	3.8
C3	3.3	3.8
C4	7.3	7.6
C5	1.1	
C6	0.0

Veh #1	Veh #2
Delta-U (mph)		
(BASIS: Damage)		
X	-8.1	-4.8
Y	1.4	-8.4
Tot	8.3	9.7
PDOF	-10.0	60.0

The Delta V (velocity changes) were computed by the damage only algorithm of the EDCRASH program. A copy of the output is included. Also a CRASH III PC program was conducted for comparison and a copy of the results is included in the Appendix "A"

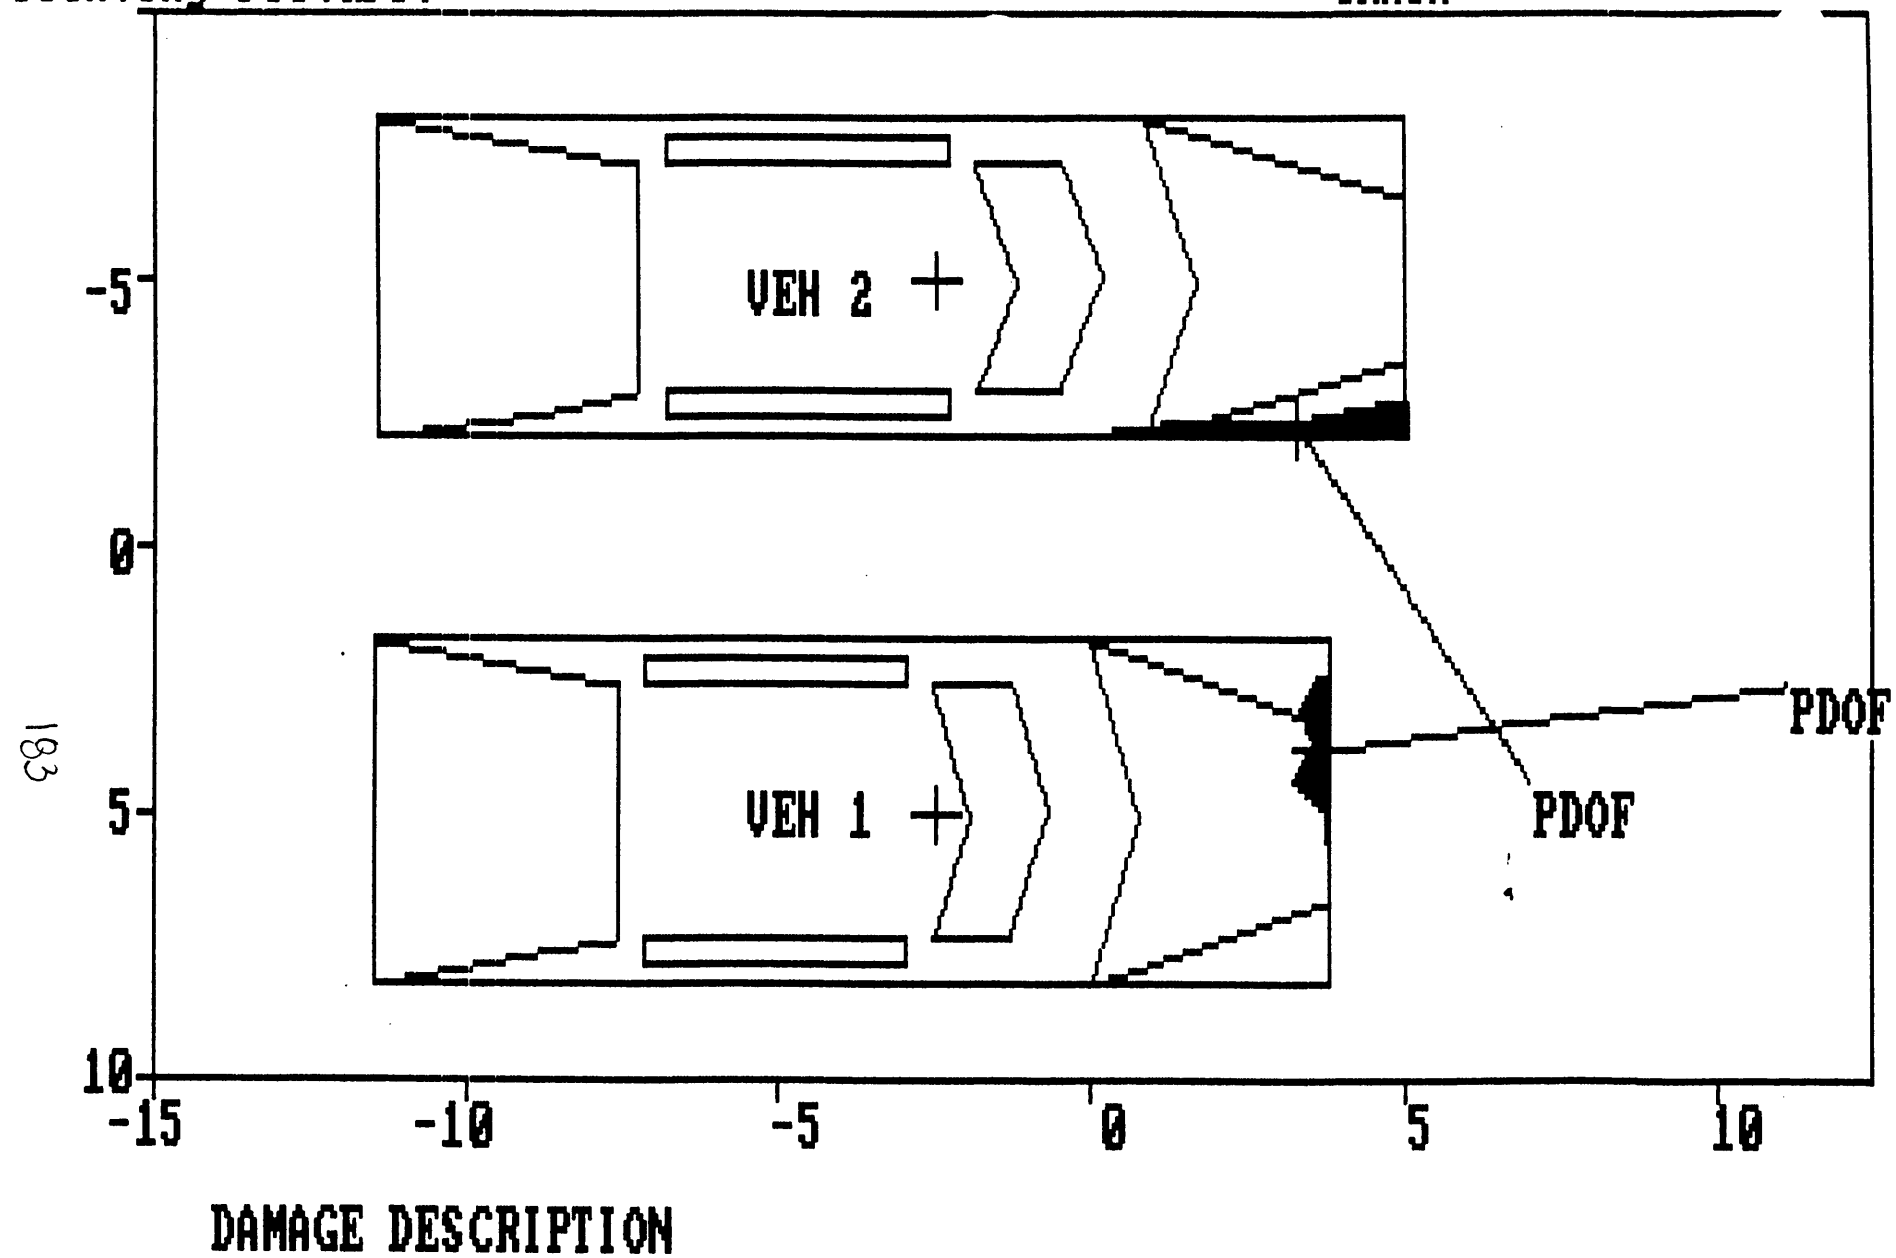
SUMMARY OF CRASHPC RESULTS (USING SPINOUT)

DSI-94-AB-20
